TR6 Rear Fender Repair Complete

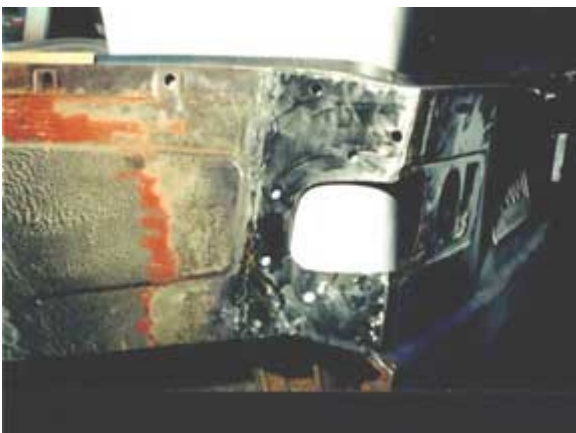
The very top edge of the inner fender between the "B" post and the beginning of the rear deck was eaten away. A new panel of 16ga steel was mig welded in place.
