TR6 Rear Fender Rust

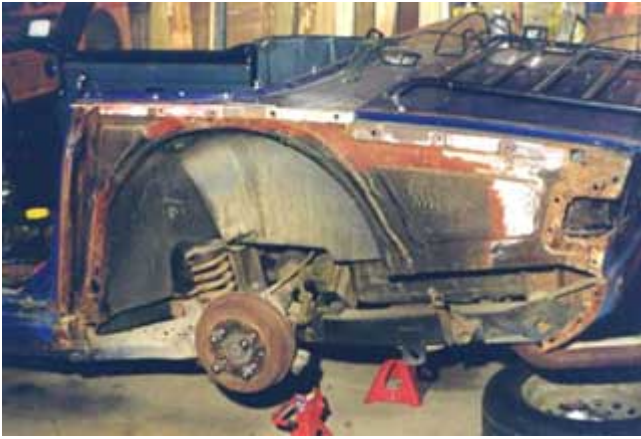
Rear fenders hide much of the damage rust can do to a TR6.

Inside the fenders there are no wheel wells to contain the dirt and water spray kicked up by the tires. The tires constantly feed the assault on the "B" posts. Water, dirt, or in my case, road salt, pile up behind the "B" post. To the rear there is nothing to slow the assault either. Built into the very back of the rear fenders is a box that houses the tail lights. This box is one of the first things to show rust on a TR6. Eventually rust will hole the box and you will find dirt and water in the trunk. When buying a TR6 look carefully at the back of the tail lights, if there is sand, the box within the fender is damaged. Rust first appeared on my rear fenders on the outside of the fender where the box is spot welded. The inner fender where the taillight box intersects was also holed by rust.

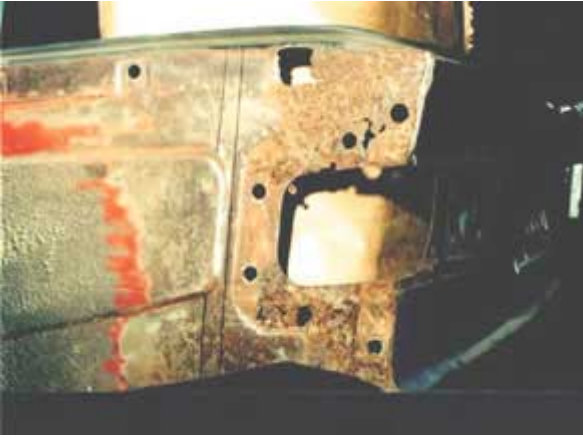
The last picture shows the inside of the heavily damaged left rear fender with most of the box missing. The same fender has damage (and Bondo) along its inner upper edge where the trunk lids intersect.
