Intercooled TR6

June 2006

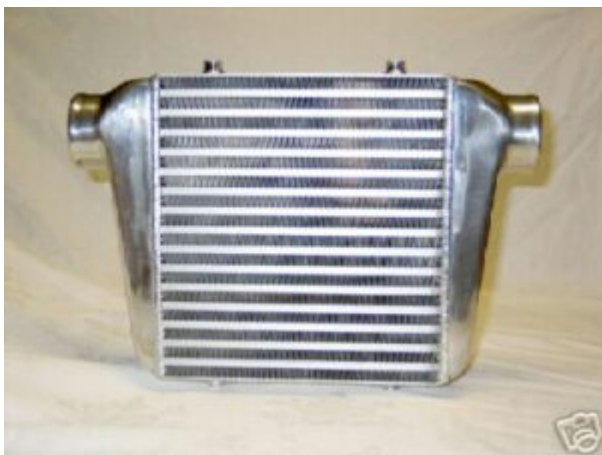
Finding an intercooler that would fit in the narrow confines of a TR6 has taken some time. I've searched sites and monitored ebay all winter. Finally on ebay appeared an intercooler listed for a Civic or Integra. It handles up to 500Hp and measures 18" wide, 12" tall, three inches thick and has 2.5" ports. The ports will need to be cut off and 2.75" aluminum tubing welded on at the proper angles. Since purchasing this unit I came across a unit used on twin turbo 300ZX's that might be an easier install. Once again let me say that the tubing used on this installation is oversize making the install that much more difficult because of space limitations. Smaller tubing may not give the same look but

Fitting the intercooler is part of my "clean up the loose ends" campaign. I want to have the car finished or nearly so before the British Invasion Show at Stowe VT in September 2006. Not only finishing up my planned projects but the little things that are not done as nicely as they could be. Things like hose and harness routing, brackets, and clean up some of my welds, etc. This is the intercooler after I welded 2.75 inch tubing ports in place.

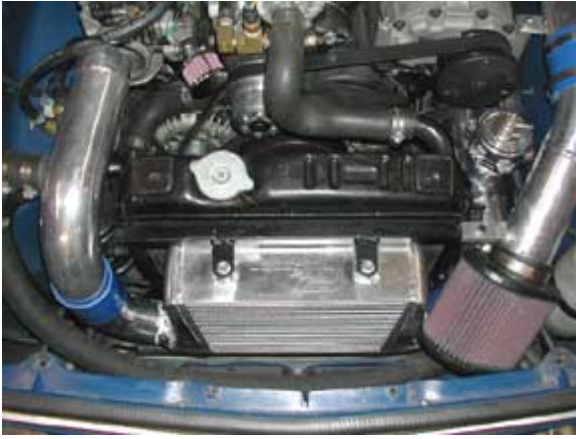
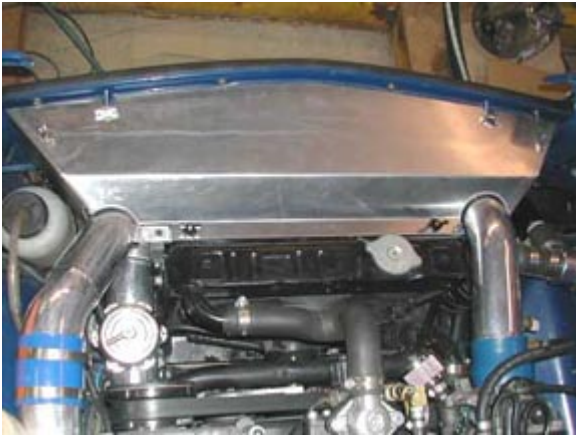
The top cover is held in place with Dzus wing nut fasteners and a couple of plastic wing nuts. I wanted to be able to easily remove it to service the air cleaner. The real time consuming portion is cutting holes for the tubing. As the tubing is attached to an engine that moves, a bit clearance is needed around all the cutouts. A white nylon edging rings the cut outs to help protect the tube and dress things up. All in all it is a nice looking installation. On the downside is after all that work to fit the intercooler and cold air intake they are now hidden. Click on the photos below for a larger view.

The top cover is made from some of the same sheeting. I did have the luxury of doing some of the longer bends at my friends shop on his break. Round trip to his takes about 45 minutes so only critical bends were done there. The shorter bends were done with a vise or over the edge of the bench with a wooden block and hammer. Offsets in the panels were done with triangular pieces and riveted in place. At the bottom, holes were drilled to align with the horn bracket mounting bolts into the frame.. The brackets will go back in place as will the horns.
